**Flood Control Project Maintenance
Levee Inspections**

2019 Channel Summary Report

San Joaquin County Flood Control and Water Conservation District

Levee Inspection Report By Mile - Channel 2019

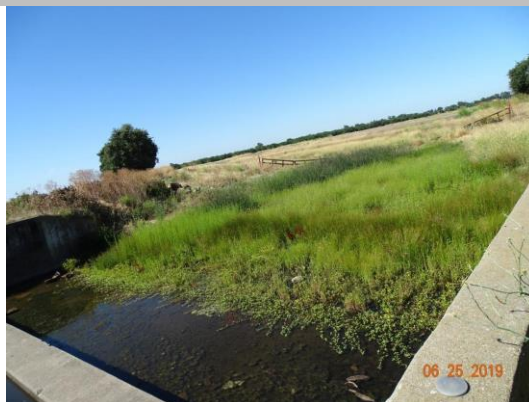
Photo 1 of 2 : CH_2019_NA0017_43_31_20190717_00011.jpg

Inspector Comments: Minimal vegetation in the channel should not impede the flow.

View of vegetation in diversion channel downstream of weir. Summer 2019

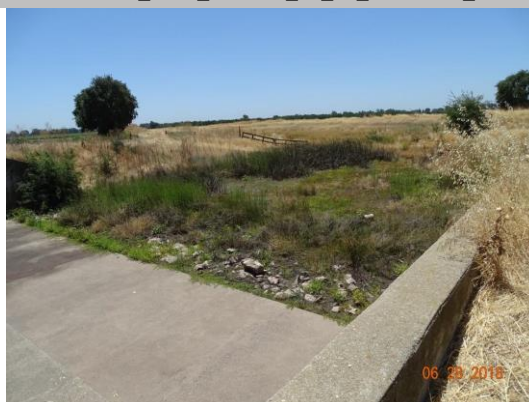
Photo 2 of 2 : CH_2019_NA0017_43_31_20190606_00009.jpg

View of the vegetation in the diversion channel looking downstream during 2018 inspection.

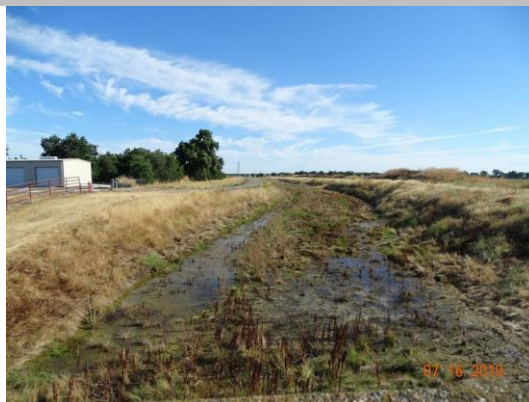
Photo 1 of 2 : CH_2019_NA0017_43_11_20190717_00012.jpg

Inspector Comments: The Minimal vegetation in the channel doesn't appear to obstruct the flow of the channel.

View of vegetation in diversion channel looking upstream. Summer 2019

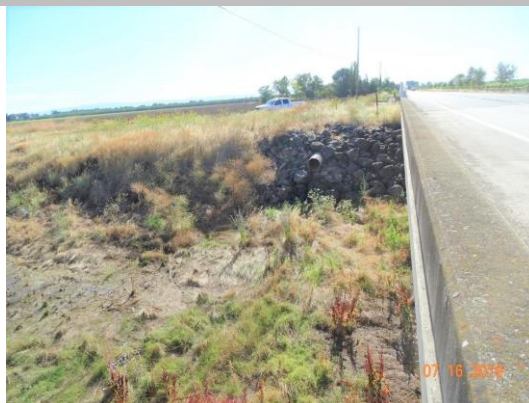
Photo 2 of 2 : CH_2019_NA0017_43_14_20190717_00016.jpg

View of upstream revetments on the left bank of channel. Summer 2019

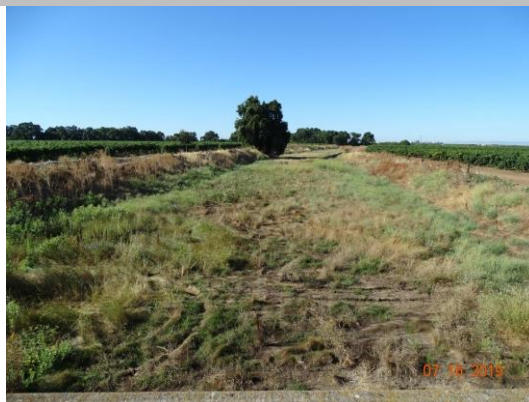
Photo 1 of 2 : CH_2019_NA0017_43_16_20190717_00017.jpg

Check Point / View				
Farmington Rd/ Hwy 4 / Down				
Rating **	A	Issue No.	16	GPS Lat/Long
Issue Type +	Ma	Location *		37.930250 °
Category	Rivers, Channels & Designated Flood			-120.991220 °
Item	Vegetation & Obstructions			
DWR ID	DWR_NA0017_43_c_2012_16			
Action/Comments				
Inspector Comments: Minimal vegetation is present in the channel but it doesn't appear to obstruct the flow of the channel.

View of vegetation looking downstream of the channel. Summer 2019

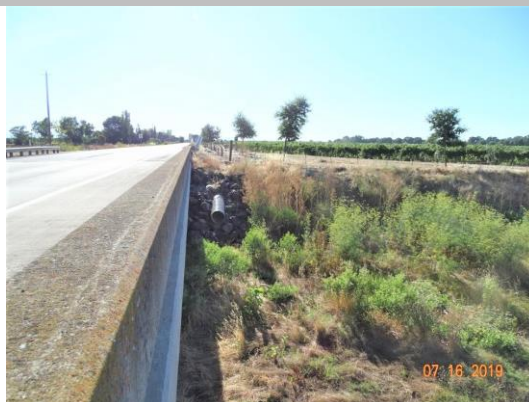
Photo 2 of 2 : CH_2019_NA0017_43_19_20190717_00027.jpg

Check Point / View				
Farmington Rd/ Hwy 4 / Down (cont)				
Rating **	A	Issue No.	19 (cont)	GPS Lat/Long
Issue Type +	Ma	Location *		37.930250 °
Category	Rivers, Channels & Designated Flood			-120.991220 °
Item	Revetments			
DWR ID	DWR_NA0017_43_c_2012_19			
Action/Comments				
Inspector Comments: Existing riprap appears to be properly maintained.

View of the revfetments on the left bank of channel looking downstream.
Summer 2019

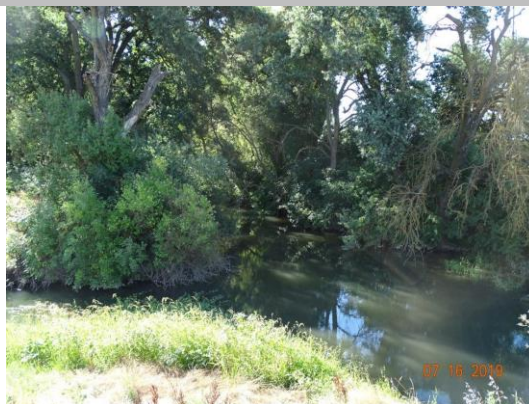
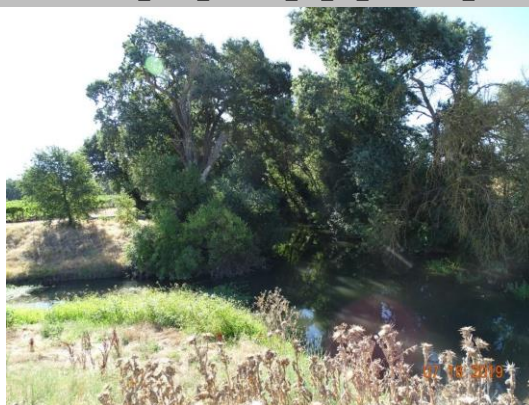
Inspector Comments: Vegetation growth in the channel does not appear to impede the flow.

View of the confluence. Summer 2019

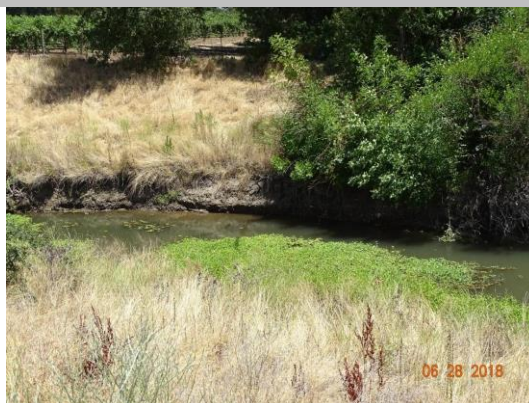
Photo 3 of 3 : CH_2019_NA0017_43_23_20190606_00008.jpg

Minimal erosion on left bank of channel at confluence, 2018

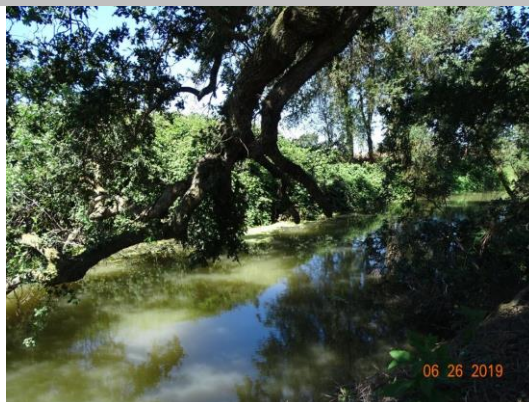
Photo 1 of 3 : CH_2019_NA0017_42_6_20190718_00052.jpg

View of vegetation looking downstream. Summer 2019

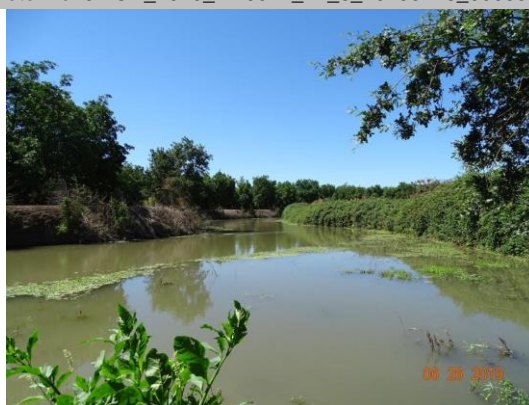
Photo 2 of 3 : CH_2019_NA0017_42_6_20190718_00053.jpg

View of vegetation looking upstream at the confluence. Summer 2019

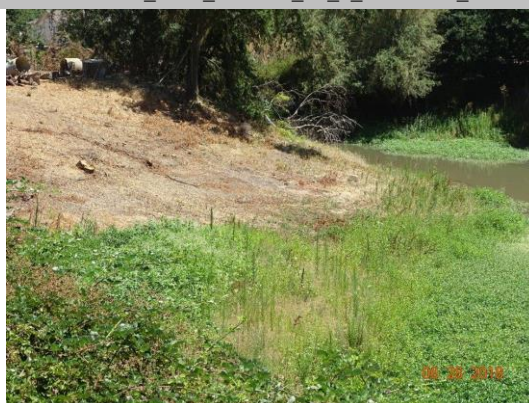
Photo 3 of 3 : CH_2019_NA0017_42_6_20190611_00001.jpg

View of the vegetation on the upstream of the channel, 2018.

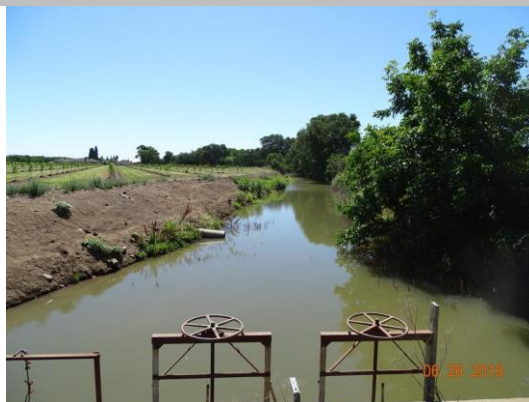
Photo 1 of 2 : CH_2019_NA0017_42_11_20190718_00054.jpg

Inspector Comments: There is minimal vegetation within the channel, flow is not likely to be impeded.

View of vegetation looking upstream. Summer 2019

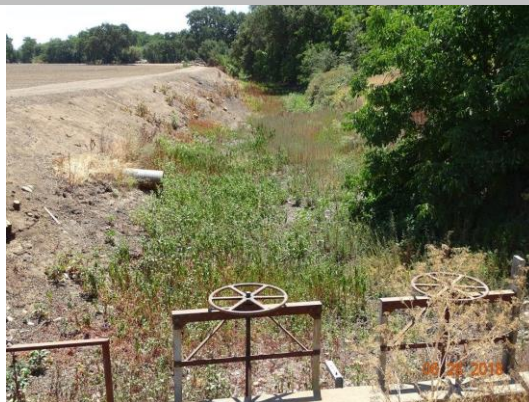
Photo 2 of 2 : CH_2019_NA0017_42_11_20190611_00003.jpg

View of the channel looking upstream during 2018 inspection.

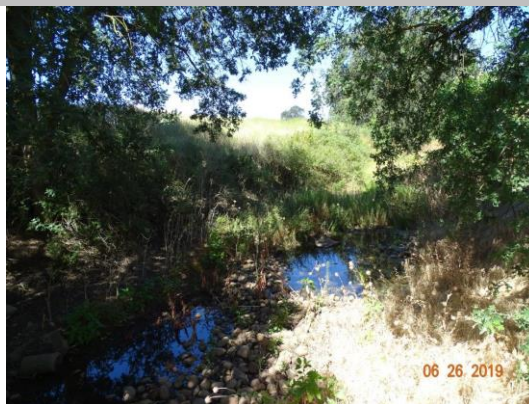
Photo 1 of 2 : CH_2019_NA0017_42_16_20190718_00056.jpg

Rating **	A	Issue No.	16	GPS Lat/Long
Issue Type +	Ma	Location *		37.920584 °
Category	Rivers, Channels & Designated Flood			-121.037914 °
Item	Vegetation & Obstructions			
DWR ID	DWR_NA0017_42_c_2012_16			
Action/Comments				
Inspector Comments: There is minimal vegetation within the channel, flow is not likely to be impeded.

View of vegetation looking downstream. Summer 2019

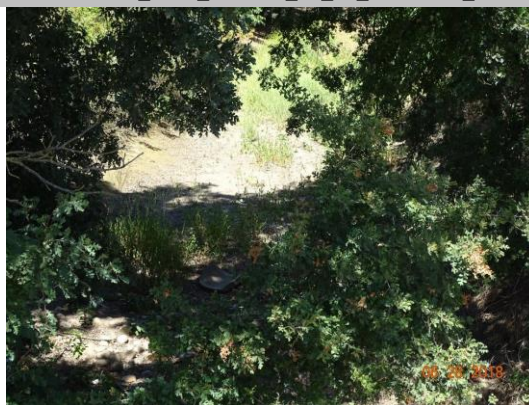
Photo 2 of 2 : CH_2019_NA0017_42_16_20190611_00005.jpg

View of the vegetation on the channel looking downstream during 2018 inspection.

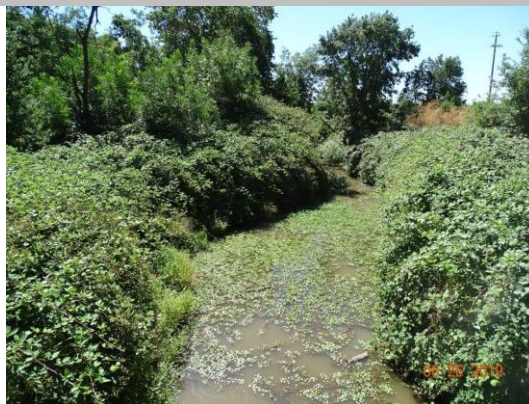
Photo 1 of 1 : CH_2019_NA0017_42_21_20190718_00057.jpg

Rating **	A	Issue No.	21	GPS Lat/Long
Issue Type +	Ma	Location *		37.918960 °
Category	Rivers, Channels & Designated Flood			-121.056260 °
Item	Vegetation & Obstructions			
DWR ID	DWR_NA0017_42_c_2012_21			
Action/Comments				
Inspector Comments: There is minimal vegetation within the channel, flow is not likely to be impeded.

View of vegetation looking upstream. Summer 2019

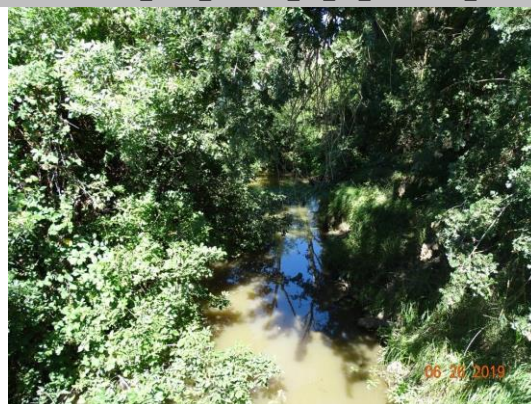
Photo 1 of 1 : CH_2019_NA0017_42_26_20190719_00058.jpg

Inspector Comments: Vegetation on channel slopes is dense, but channel flow is not impeded.

View of vegetation looking downstream of channel. Summer 2019

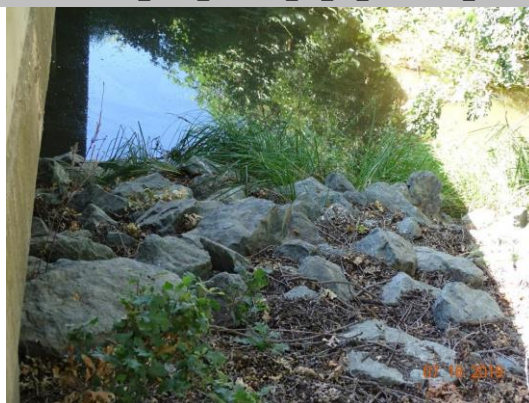
Photo 1 of 2 : CH_2019_NA0017_42_29_20190719_00059.jpg

Inspector Comments: Riprap is visible and appears to be undamaged.

View of existing revetments on the right bank looking downstream.
Summer 2019

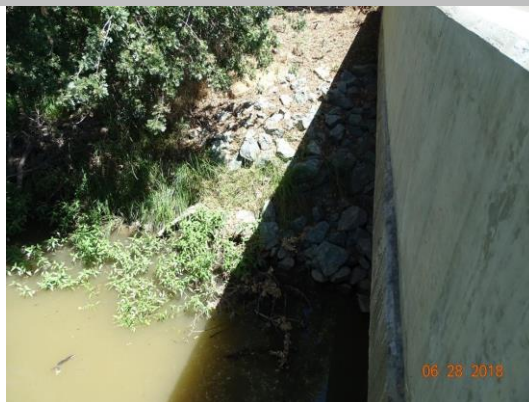
Photo 2 of 2 : CH_2019_NA0017_42_29_20190611_00011.jpg

Inspector Comments: Riprap is visible and appears to be undamaged.

View of existing revetments on the right bank of the channel looking downstream, 2018.

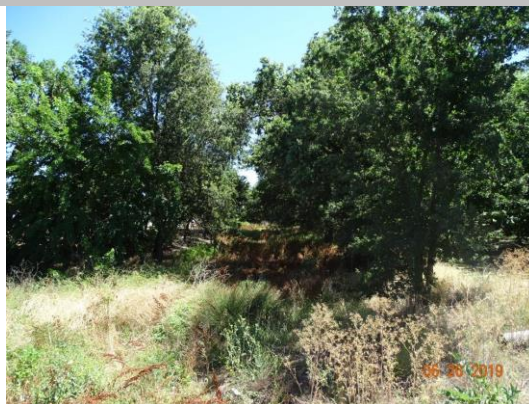
Photo 1 of 1 : CH_2019_NA0017_42_31_20190719_00060.jpg

Rating **	A	Issue No.	31	GPS Lat/Long
Issue Type +	Ma	Location *		37.921460 °
Category	Rivers, Channels & Designated Flood			-121.147570 °
Item	Vegetation & Obstructions			
DWR ID	DWR_NA0017_42_c_2012_31			
Action/Comments				
Inspector Comments: There is minimal vegetation within the channel, flow is not likely to be impeded.

View of vegetation looking upstream. Summer 2019

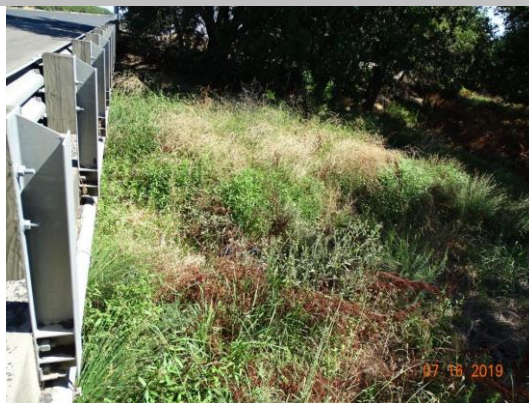
Photo 1 of 2 : CH_2019_NA0017_42_35_20190719_00061.jpg

Inspector Comments: The trash and debris documented on the 2018 inspection has been removed and the channel is currently free of trash, debris, or obstructions.

View of debris clean up looking upstream. Summer 2019

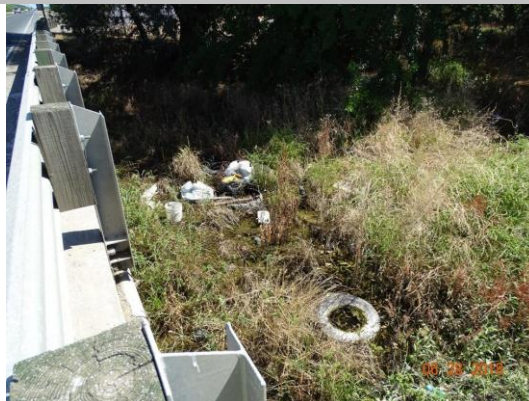
Photo 2 of 2 : CH_2019_NA0017_42_35_20190611_00014.jpg

View of the debris in the channel looking upstream during 2018 inspection.

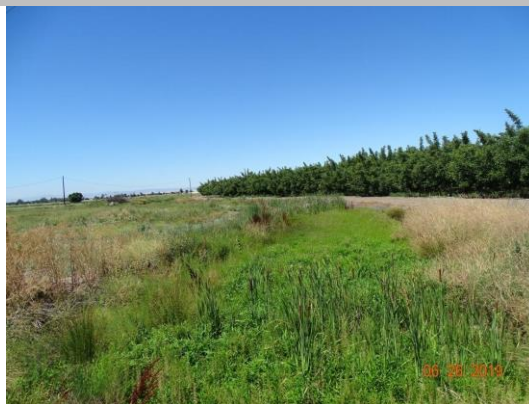
Photo 1 of 1 : CH_2019_NA0017_42_36_20190719_00062.jpg

Rating **	A	Issue No.	36	GPS Lat/Long
Issue Type +	Ma	Location *		37.921460 °
Category	Rivers, Channels & Designated Flood			-121.147570 °
Item	Vegetation & Obstructions			
DWR ID	DWR_NA0017_42_c_2012_36			
Action/Comments				
Inspector Comments: There is minimal vegetation within the channel, flow is not likely to be impeded.

View of vegetation on the channel looking downstream. Summer 2019

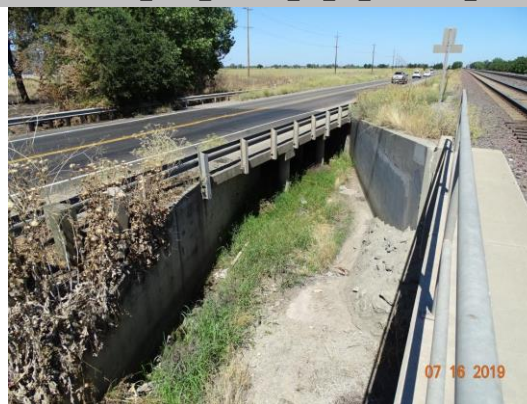
Photo 1 of 1 : CH_2019_NA0017_42_41_20190719_00063.jpg

Inspector Comments: There is minimal vegetation within the channel, flow is not likely to be impeded.

View of upstream channel crossing. Summer 2019

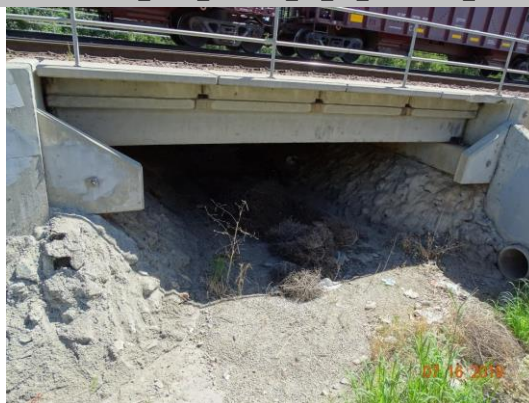
Photo 1 of 1 : CH_2019_NA0017_42_44_20190723_00079.jpg

Rating **	A	Issue No.	44	GPS Lat/Long
Issue Type +	Ma	Location *		37.915879 °
Category	Rivers, Channels & Designated Flood			-121.189095 °
Item	Revetments			
DWR ID	DWR_NA0017_42_c_2012_44			
Action/Comments				
Inspector Comments: Riprap is visible and appears to be undamaged.

View of revetments looking upstream. Summer 2019

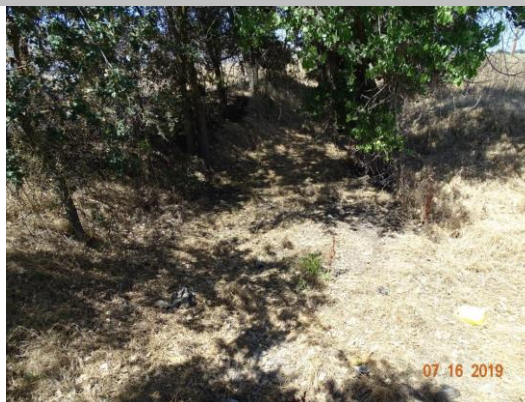
Photo 1 of 1 : CH_2019_NA0017_42_46_20190719_00064.jpg

Inspector Comments: There is minimal vegetation within the channel, flow is not likely to be impeded.

View of vegetation looking downstream. Summer 2019

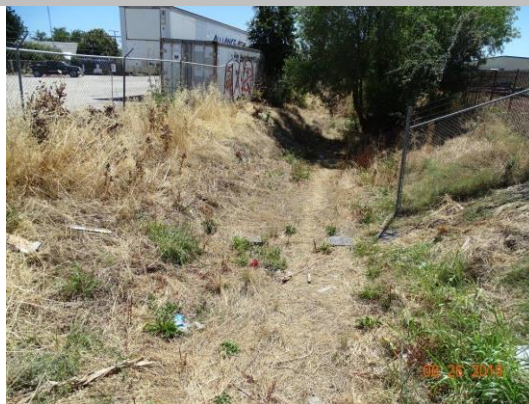
Photo 1 of 1 : CH_2019_NA0017_42_51_20190719_00065.jpg

Rating **	A	Issue No.	51	GPS Lat/Long
Issue Type +	Ma	Location *		37.913239 °
Category	Rivers, Channels & Designated Flood			-121.225915 °
Item	Vegetation & Obstructions			
DWR ID	DWR_NA0017_42_c_2012_51			
Action/Comments				
Inspector Comments: There is minimal vegetation within the channel, flow is not likely to be impeded.

View of vegetation looking upstream. Summer 2019

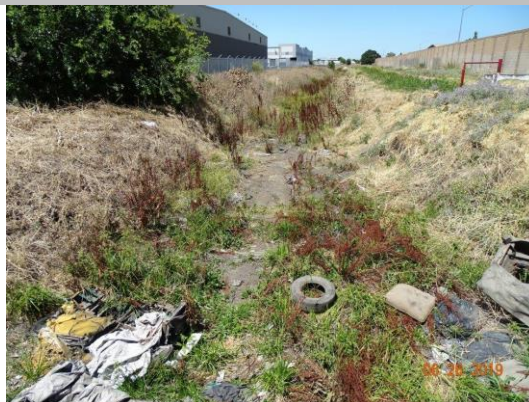
Photo 1 of 1 : CH_2019_NA0017_42_56_20190719_00066.jpg

Rating **	A	Issue No.	56	GPS Lat/Long
Issue Type +	Ma	Location *		37.913239 °
Category	Rivers, Channels & Designated Flood			-121.225915 °
Item	Vegetation & Obstructions			
DWR ID	DWR_NA0017_42_c_2012_56			
Action/Comments				
Inspector Comments: There is minimal vegetation within the channel, flow is not likely to be impeded.

View of vegetation looking downstream. Summer 2019

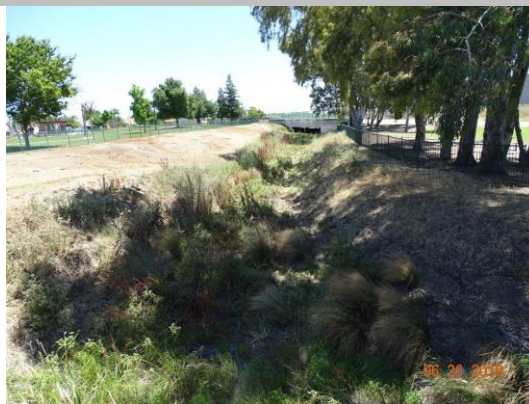
Photo 1 of 1 : CH_2019_NA0017_42_61_20190719_00068.jpg

Rating **	A	Issue No.	61	GPS Lat/Long
Issue Type +	Ma	Location *		37.914290 °
Category	Rivers, Channels & Designated Flood			-121.238800 °
Item	Vegetation & Obstructions			
DWR ID	DWR_NA0017_42_c_2012_61			
Action/Comments				
Inspector Comments: There is minimal vegetation within the channel, flow is not likely to be impeded.

View of vegetation looking upstream. Summer 2019

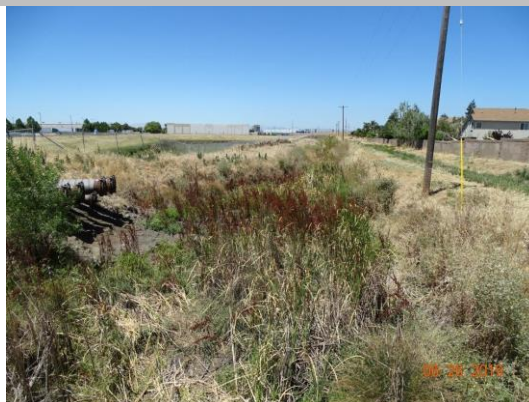
Photo 1 of 2 : CH_2019_NA0017_42_66_20190719_00069.jpg

Inspector Comments: There is minimal vegetation within the channel, flow is not likely to be impeded.

View of vegetation looking downstream. Summer 2019

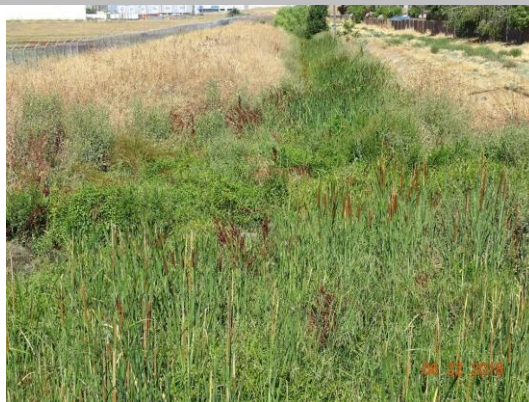
Photo 2 of 2 : CH_2019_NA0017_42_66_20190611_00026.jpg

View of the channel looking downstream. Summer 2018

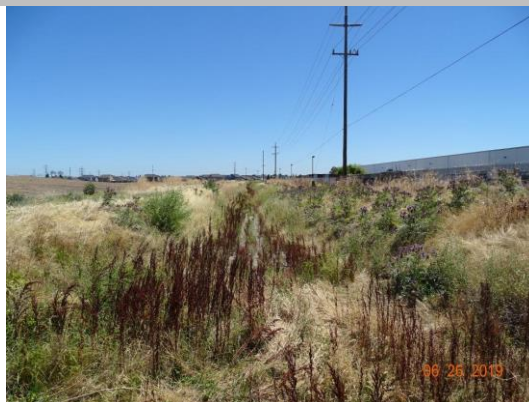
Photo 1 of 1 : CH_2019_NA0017_42_71_20190719_00071.jpg

Check Point / View				
South B Street / Up				
Rating **	A	Issue No.	71	GPS Lat/Long
Issue Type +	Ma	Location *		37.913716 °
Category	Rivers, Channels & Designated Flood			-121.247761 °
Item	Vegetation & Obstructions			
DWR ID	DWR_NA0017_42_c_2012_71			
Action/Comments				
Inspector Comments: There is minimal vegetation within the channel, flow is not likely to be impeded.

View of vegetation looking upstream. Summer 2019

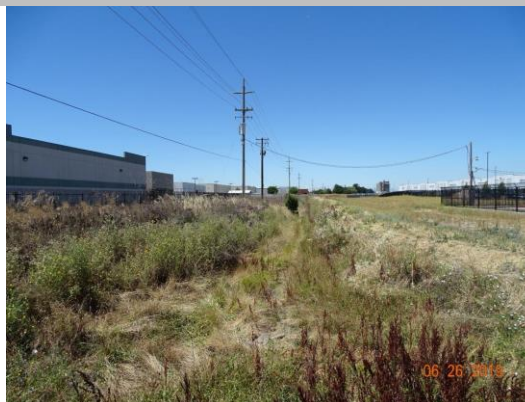
Photo 1 of 1 : CH_2019_NA0017_42_76_20190719_00070.jpg

Inspector Comments: There is minimal vegetation within the channel, flow is not likely to be impeded.

View of vegetation looking downstream. Summer 2019

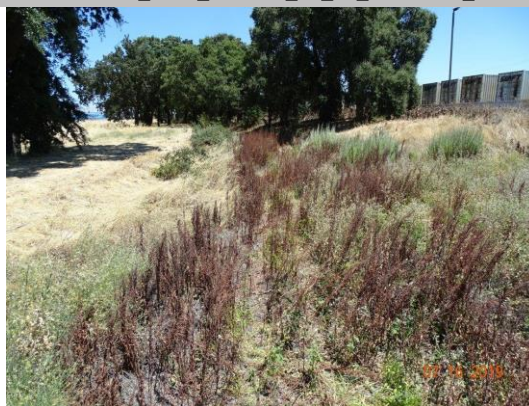
Photo 1 of 2 : CH_2019_NA0017_42_81_20190719_00072.jpg

Inspector Comments: There is minimal vegetation within the channel, flow is not likely to be impeded.

View of vegetation looking upstream. Summer 2019

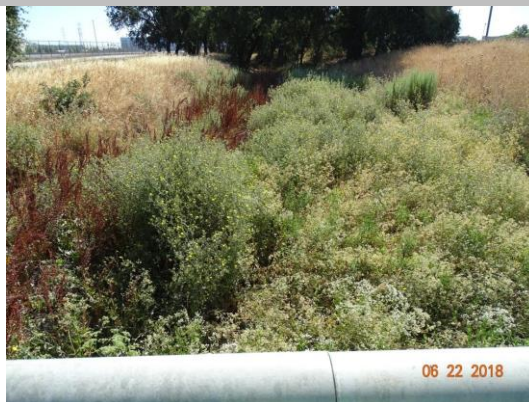
Photo 2 of 2 : CH_2019_NA0017_42_81_20190611_00032.jpg

Rating **	A	Issue No.	81 (cont)	GPS Lat/Long
Issue Type +	Ma	Location *		37.912070 °
Category	Rivers, Channels & Designated Flood			-121.258811 °
Item	Vegetation & Obstructions			
DWR ID	DWR_NA0017_42_c_2012_81			
Action/Comments				
Inspector Comments: There is minimal vegetation within the channel, flow is not likely to be impeded.

View of the vegetation on the channel looking upstream. Summer 2018

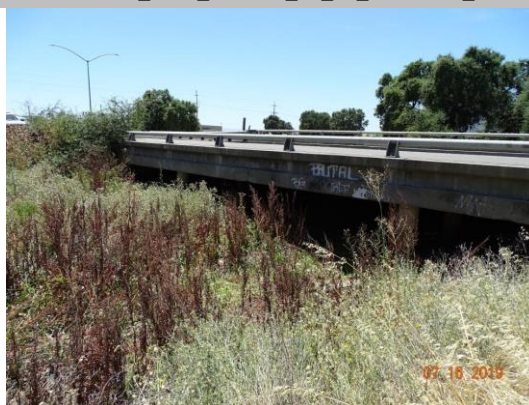
Photo 1 of 2 : CH_2019_NA0017_42_85_20190719_00073.jpg

Rating **	A	Issue No.	85	GPS Lat/Long
Issue Type +	Ma	Location *		37.912070 °
Category	Rivers, Channels & Designated Flood			-121.258811 °
Item	Encroachments			
DWR ID	DWR_NA0017_42_c_2012_85			
Action/Comments				
Inspector Comments: The encroachment and obstruction documented on the 2018 inspection has been removed and the channel is currently free of trash, debris, or obstructions.

View of upstream bridge crossing. Summer 2019

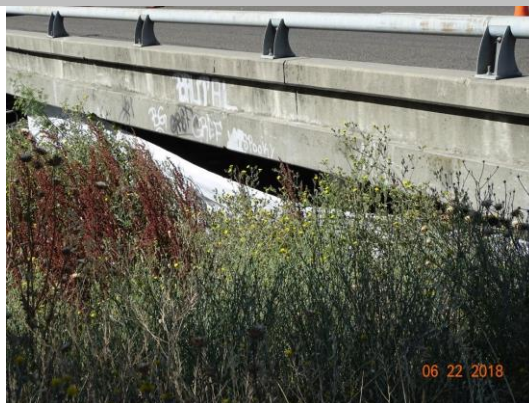
Photo 2 of 2 : CH_2019_NA0017_42_85_20190611_00034.jpg

View of encroachment on upstream side of channel, 2018.

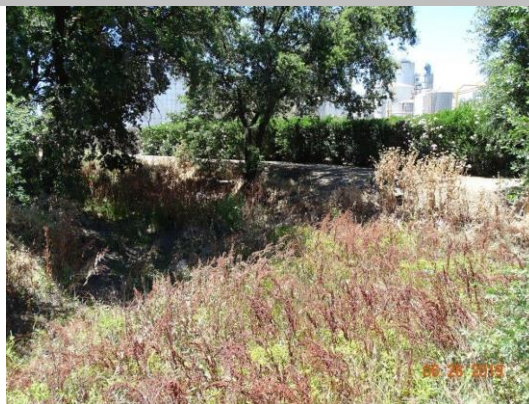
Photo 1 of 1 : CH_2019_NA0017_42_86_20190719_00074.jpg

Rating **	A	Issue No.	86	GPS Lat/Long
Issue Type +	Ma	Location *		37.912070 °
Category	Rivers, Channels & Designated Flood			-121.258811 °
Item	Vegetation & Obstructions			
DWR ID	DWR_NA0017_42_c_2012_86			
Action/Comments				
Inspector Comments: There is minimal vegetation within the channel, flow is not likely to be impeded.

View of vegetation looking downstream. Summer 2019

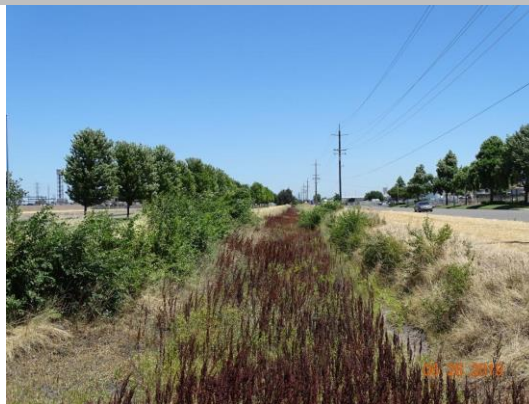
Photo 1 of 1 : CH_2019_NA0017_42_91_20190719_00075.jpg

Inspector Comments: There is minimal vegetation within the channel, flow is not likely to be impeded.

View of vegetation looking upstream. Summer 2019

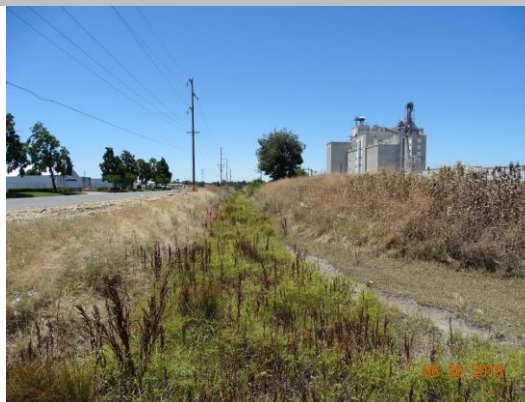
Photo 1 of 1 : CH_2019_NA0017_42_96_20190719_00076.jpg

Inspector Comments: There is minimal vegetation within the channel, flow is not likely to be impeded.

View of vegetation looking downstream. Summer 2019

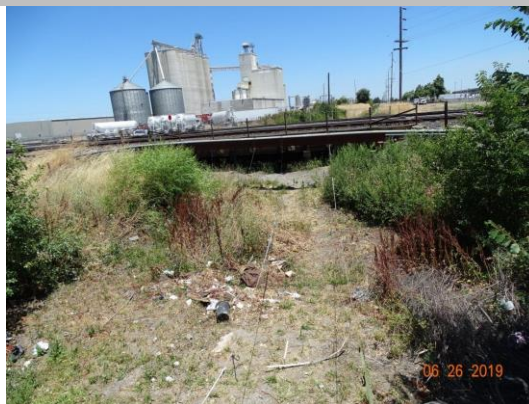
Photo 1 of 2 : CH_2019_NA0017_42_101_20190719_00077.jpg

Inspector Comments: There is vegetation within the channel which may impede the flow.

View of vegetation looking upstream. Summer 2019

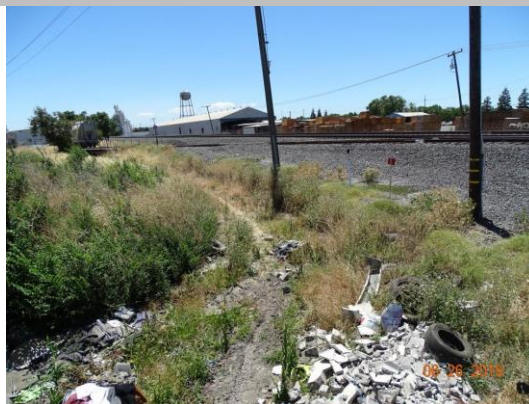
Photo 1 of 1 : CH_2019_NA0017_42_106_20190723_00078.jpg

Inspector Comments: There is vegetation and obstructions within the channel which may impede the flow.

View of vegetation looking downstream. Summer 2019

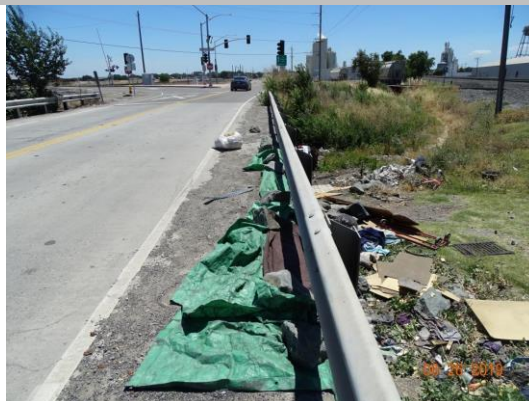
Photo 1 of 1 : CH_2019_NA0017_42_109_20190723_00084.jpg

Rating **	M	Issue No.	109	GPS Lat/Long
Issue Type +	Ma	Location *		37.907158 °
Category	Rivers, Channels & Designated Flood			-121.273935 °
Item	Revetments			
DWR ID	DWR_NA0017_42_c_2012_109			
Action/Comments				
Inspector Comments: Revetment has been displaced by homeless encampment activities.

View looking downstream of revetments displaced by homeless encampment activities. Summer 2019

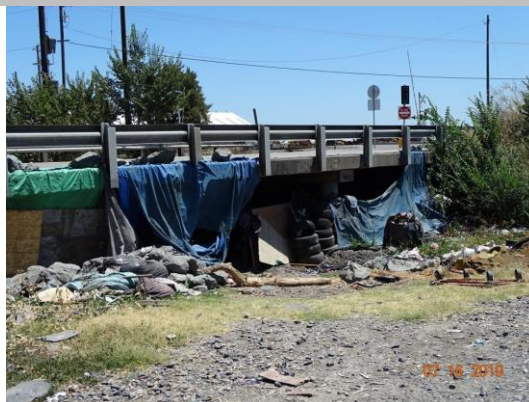
Photo 1 of 2 : CH_2019_NA0017_42_110_20190723_00082.jpg

Inspector Comments: Trash, debris and other obstructions present. Homeless encampment activities will inhibit project operations, maintenance and emergency operations.

View of trash and debris looking downstream. Summer 2019

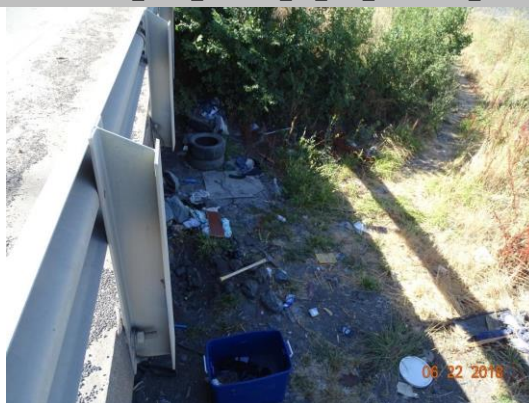
Photo 2 of 2 : CH_2019_NA0017_42_110_20190611_00048.jpg

View of debris on the downstream end of the channel. Summer 2018

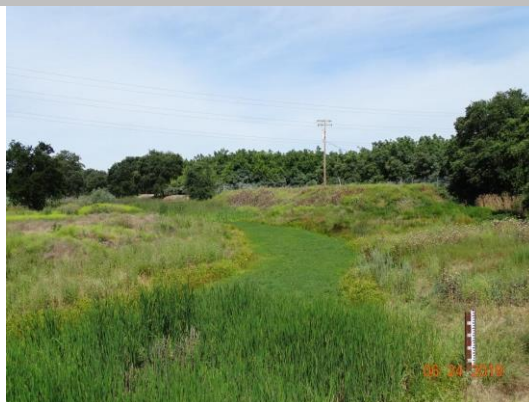
Photo 1 of 1 : CH_2019_NA0017_44_6_20190717_00049.jpg

Inspector Comments: There is vegetation within the channel which may impede the flow.

View of vegetation in channel looking downstream. Summer 2019

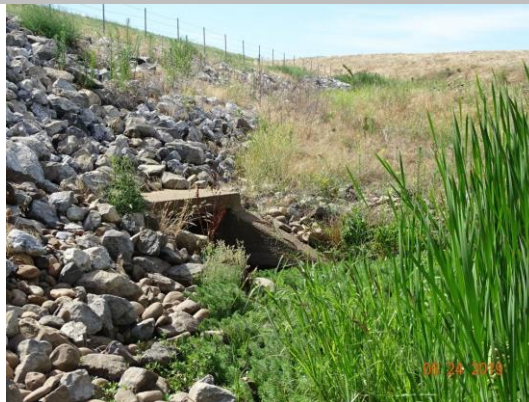
Photo 1 of 2 : CH_2019_NA0017_44_9_20190717_00050.jpg

Inspector Comments: Riprap is visible and appears to be undamaged.

View of revetment at outlet. Summer 2019

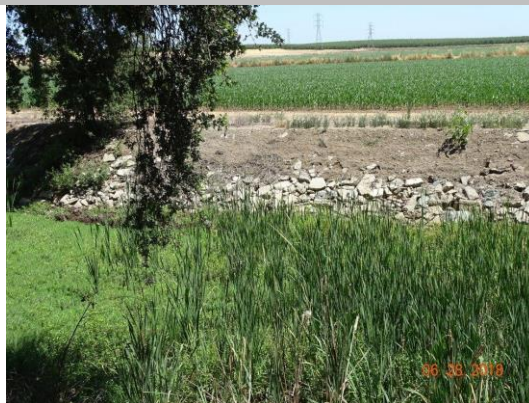
Photo 2 of 2 : CH_2019_NA0017_44_9_20190611_00002.jpg

View of the existing revetments looking downstream during 2018 inspection.

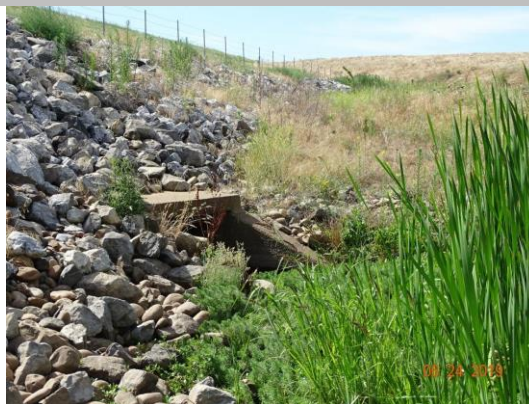
Photo 1 of 1 : CH_2019_NA0017_44_119_20190722_00088.jpg

Inspector Comments: Farmington dam pipe outfall is the start of the channel inspection. Minor debris and vegetation is present at the outfall, but capacity does not appear to be impeded.

View of Farmington pipe outfall. Summer 2019

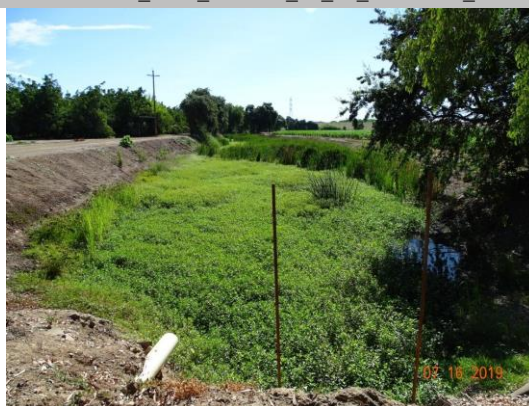
Photo 1 of 2 : CH_2019_NA0017_44_99_20190718_00051.jpg

Inspector Comments: There is vegetation within the channel which may impede the flow.

View of vegetation looking upstream. Summer 2019

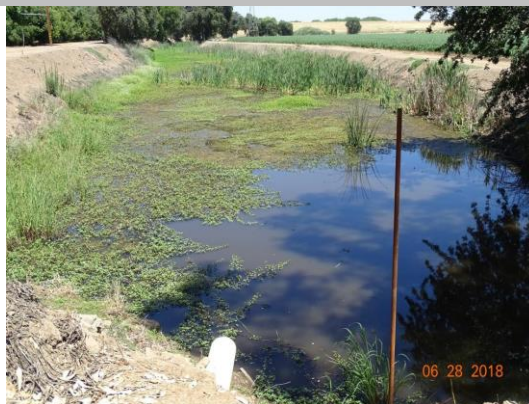
Photo 2 of 2 : CH_2019_NA0017_44_99_20190611_00036.jpg

Inspector Comments: There is vegetation within the channel which may impede the flow.

View of the vegetation on the channel looking upstream. Summer 2018

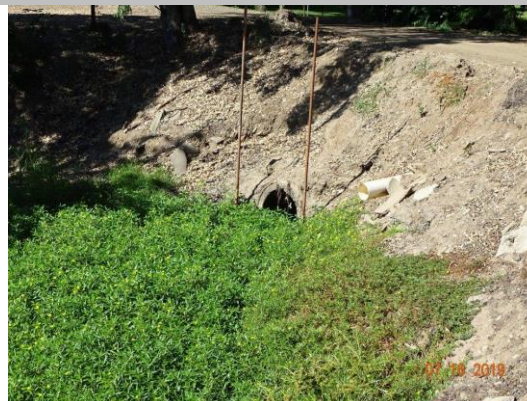
Photo 1 of 2 : CH_2019_NA0017_44_108_20190718_00052.jpg

Inspector Comments: Pipe has minor debris near inlet, however the pipe appears to be operational.

View of pipe looking upstream. Summer 2019

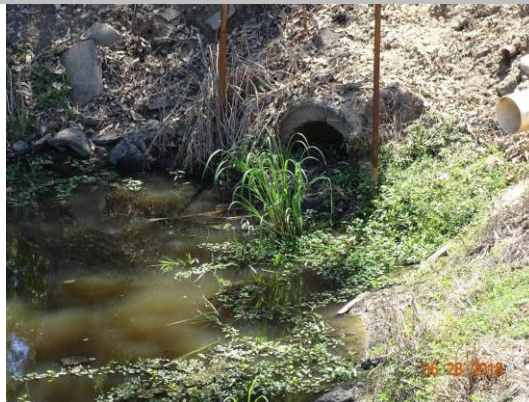
Photo 2 of 2 : CH_2019_NA0017_44_108_20190611_00038.jpg

Inspector Comments: Pipe has minor debris near inlet, however the pipe appears to be operational.

View of the pipe looking upstream of the channel. Summer 2018

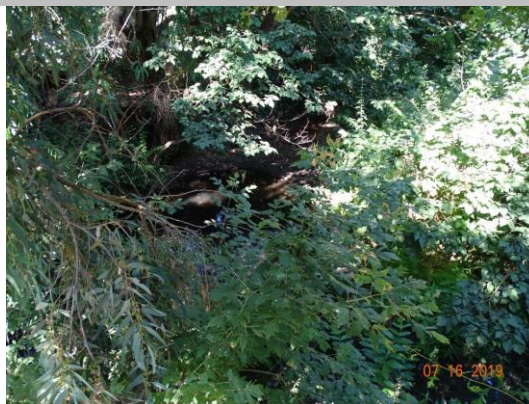
Photo 1 of 3 : CH_2019_NA0017_44_104_20190718_00053.jpg

Inspector Comments: Dense vegetation growth will impede the flow and may block approximately 50% capacity of the channel.

View of vegetation looking downstream of channel. Summer 2019

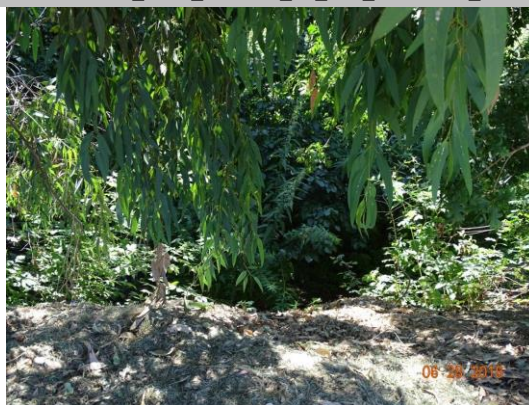
Photo 3 of 3 : CH_2019_NA0017_44_104_20190611_00037.jpg

View of the vegetation on the downstream of the channel during 2018 inspection.

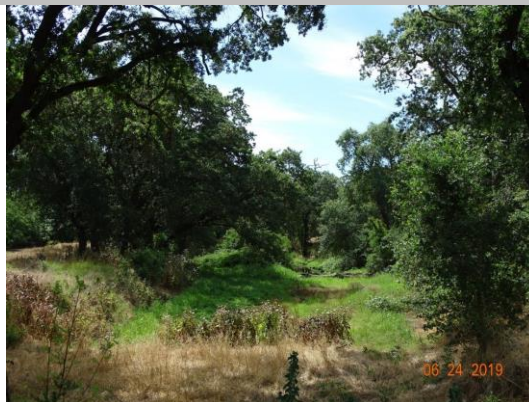
Photo 1 of 2 : CH_2019_NA0017_44_141_20190718_00056.jpg

Inspector Comments: There is vegetation and other obstructions within the channel which may impede the flow.

View of upstream vegetation, log jams and snags which may impede the channel flow. Summer 2019

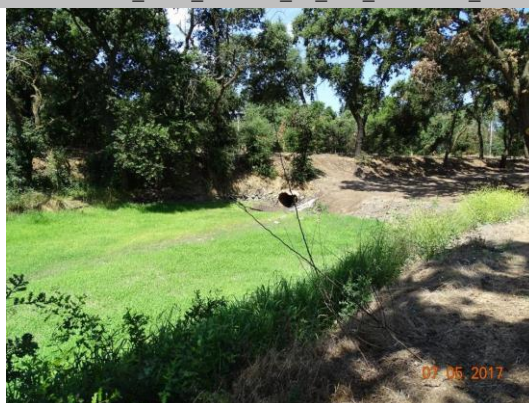
Photo 2 of 2 : CH_2019_NA0017_44_150_20190611_00046.jpg

Inspector Comments: The inlet pipe appears to be in good condition and well maintained.

View of the pipe looking upstream from the channel during 2017 inspection.

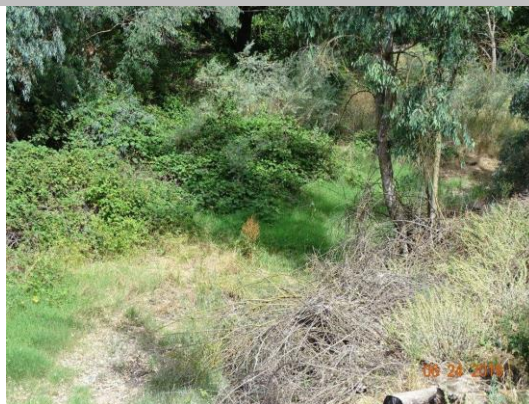
Photo 1 of 2 : CH_2019_NA0017_44_146_20190718_00060.jpg

View of vegetation looking downstream of channel. Summer 2019

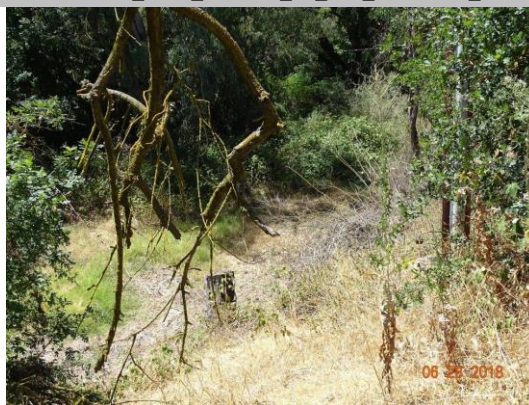
Photo 2 of 2 : CH_2019_NA0017_44_146_20190611_00045.jpg

View of the vegetation on the downstream of the channel. Summer 2018

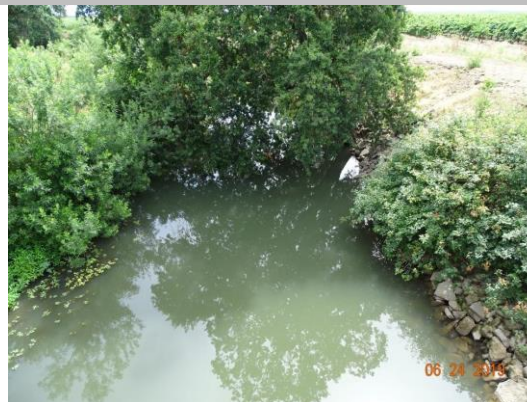
Photo 1 of 1 : CH_2019_NA0017_44_21_20190718_00061.jpg

Inspector Comments: There is minimal vegetation within the channel, flow is not likely to be impeded.

View of the channel looking upstream. Summer 2019

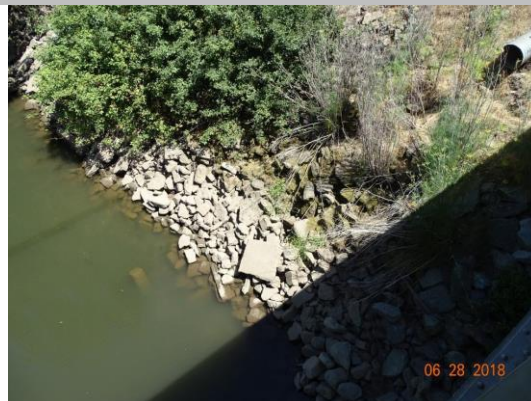
Photo 1 of 1 : CH_2019_NA0017_44_24_20190611_00004.jpg

Inspector Comments: Riprap is visible and appears to be undamaged.

Existing revetments left bank. Summer 2018

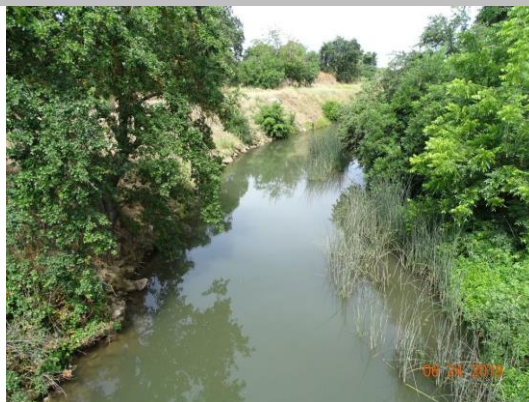
Photo 1 of 2 : CH_2019_NA0017_44_26_20190718_00062.jpg

Check Point / View				
Escalon Bellota Rd / Down				
Rating **	A	Issue No.	26	GPS Lat/Long
Issue Type +	Ma	Location *		37.925330 °
Category	Rivers, Channels & Designated Flood			-121.000120 °
Item	Vegetation & Obstructions			
DWR ID	DWR_NA0017_44_c_2012_26			
Action/Comments				
Inspector Comments: There is minimal vegetation within the channel, flow is not likely to be impeded.

View of channel looking downstream. Summer 2019

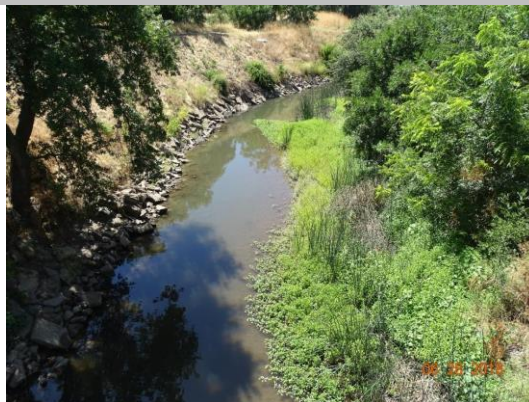
Photo 2 of 2 : CH_2019_NA0017_44_26_20190611_00005.jpg

View of the channel looking downstream during 2018 inspection.

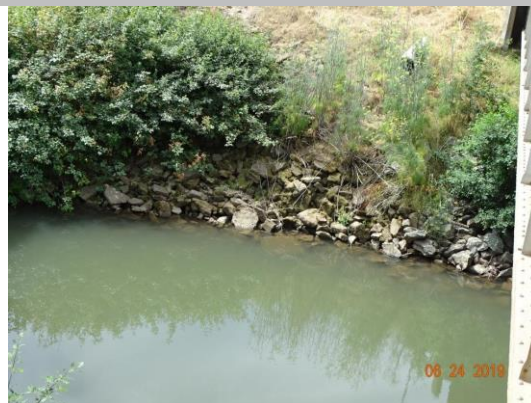
Photo 1 of 2 : CH_2019_NA0017_44_29_20190718_00063.jpg

Rating **	A	Issue No.	29	GPS Lat/Long
Issue Type +	Ma	Location *		37.925330 °
Category	Rivers, Channels & Designated Flood			-121.000120 °
Item	Revetments			
DWR ID	DWR_NA0017_44_c_2012_29			
Action/Comments				
Inspector Comments: Riprap is visible and appears to be undamaged.

View of revetments on right bank looking downstream. Summer 2019

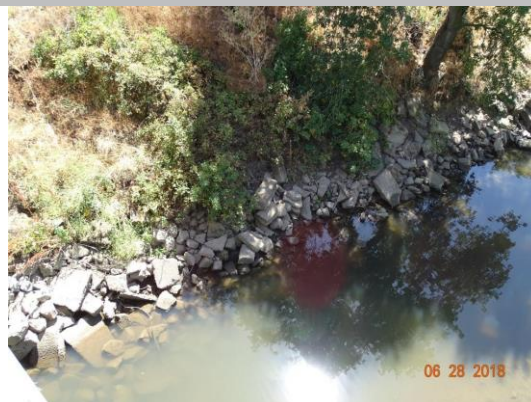
Photo 2 of 2 : CH_2019_NA0017_44_29_20190611_00006.jpg

Inspector Comments: Riprap is visible and appears to be undamaged.

View of the revetments on the left bank of the channel looking downstream during 2018 inspection.

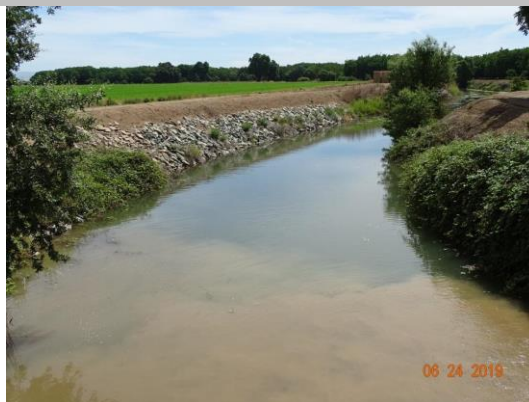
Photo 1 of 2 : CH_2019_NA0017_44_31_20190718_00064.jpg

Inspector Comments: There is minor amounts of vegetation within the channel, flow is not likely to be impeded.

View of channel looking upstream. Summer 2019

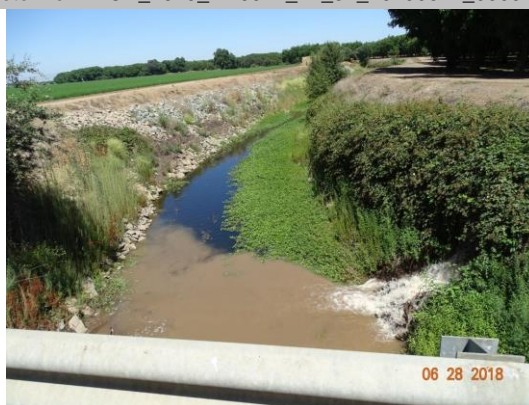
Photo 2 of 2 : CH_2019_NA0017_44_31_20190611_00007.jpg

View of the channel looking upstream during 2018 inspection.

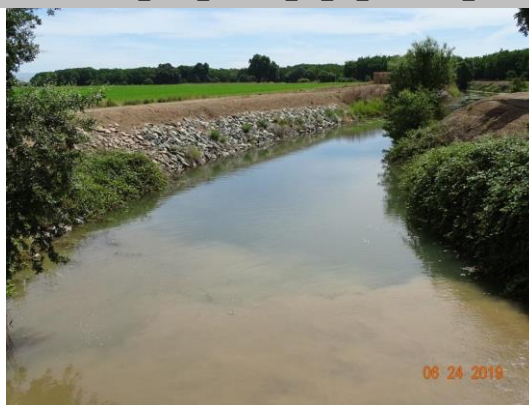
Photo 1 of 2 : CH_2019_NA0017_44_34_20190718_00065.jpg

Inspector Comments: Riprap is visible and appears to be undamaged.

View of existing revetments on right bank. Summer 2019

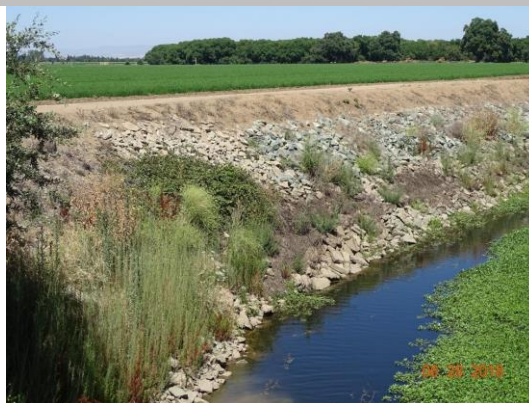
Photo 2 of 2 : CH_2019_NA0017_44_34_20190611_00008.jpg

View of the existing revetments on the right channel bank looking upstream. Summer 2018

Rating **	A	Issue No.	34 (cont)	GPS Lat/Long
Issue Type +	Ma	Location *		37.920060 °
Category	Rivers, Channels & Designated Flood			-121.027790 °
Item	Revetments			
DWR ID	DWR_NA0017_44_c_2012_34

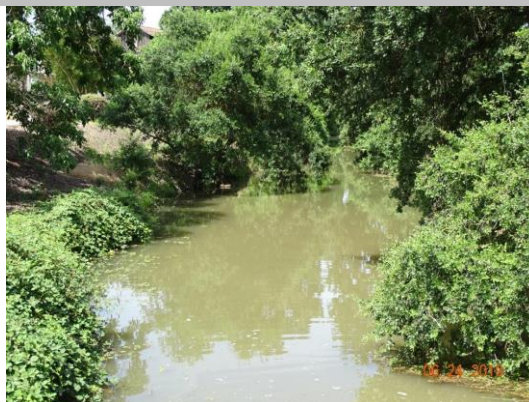
Photo 1 of 2 : CH_2019_NA0017_44_36_20190718_00066.jpg

View of channel looking downstream. Summer 2019

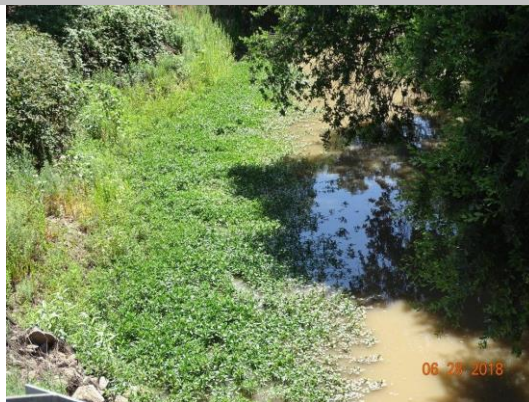
Photo 2 of 2 : CH_2019_NA0017_44_36_20190611_00009.jpg

View of the downstream reach of the channel. Summer 2018

Rating **	A	Issue No.	36 (cont)	GPS Lat/Long
Issue Type +	Ma	Location *		37.920060 °
Category	Rivers, Channels & Designated Flood			-121.027790 °
Item	Vegetation & Obstructions			
DWR ID	DWR_NA0017_44_c_2012_36

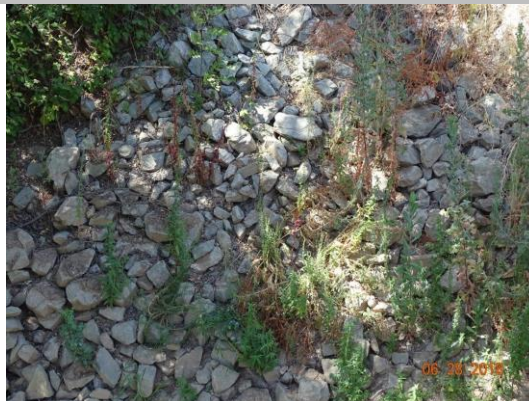
Photo 1 of 2 : CH_2019_NA0017_44_39_20190611_00011.jpg

Rating **	A	Issue No.	39	GPS Lat/Long
Issue Type +	Ma	Location *		37.920060 °
Category	Rivers, Channels & Designated Flood			-121.027790 °
Item	Revetments			
DWR ID	DWR_NA0017_44_c_2012_39			
Action/Comments				
Inspector Comments: Riprap is visible and appears to be undamaged.

View of the revetments on the right bank of the channel. Summer 2018

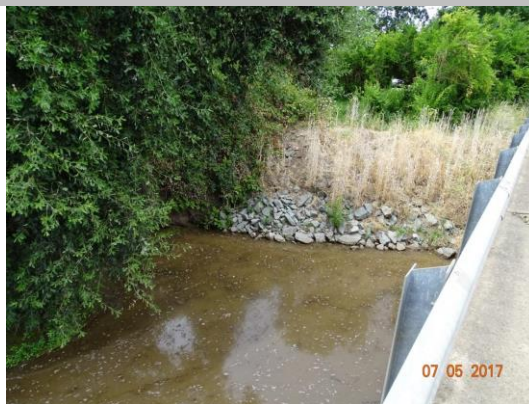
Photo 2 of 2 : CH_2019_NA0017_44_39_20190611_00012.jpg

Inspector Comments: Riprap is visible and appears to be undamaged.

View of the revetments on the right bank of the channel.

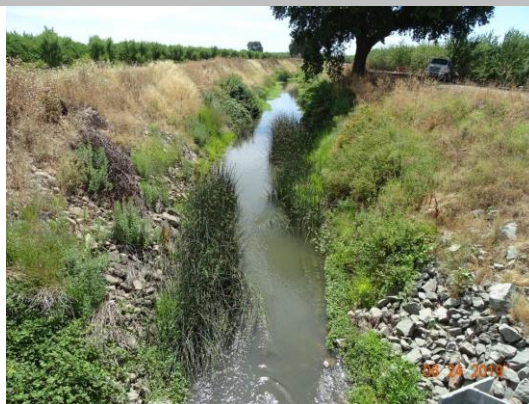
Photo 1 of 1 : CH_2019_NA0017_44_41_20190718_00067.jpg

Inspector Comments: There is minimal vegetation within the channel, flow is not likely to be impeded.

View of channel looking upstream. Summer 2019

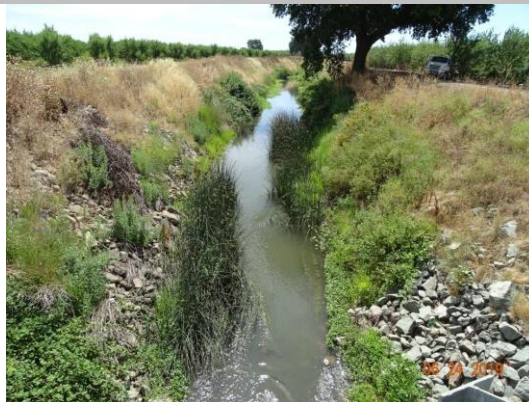
Photo 1 of 2 : CH_2019_NA0017_44_44_20190718_00068.jpg

Inspector Comments: Riprap is visible and appears to be undamaged.

View of revetment looking upstream. Summer 2019

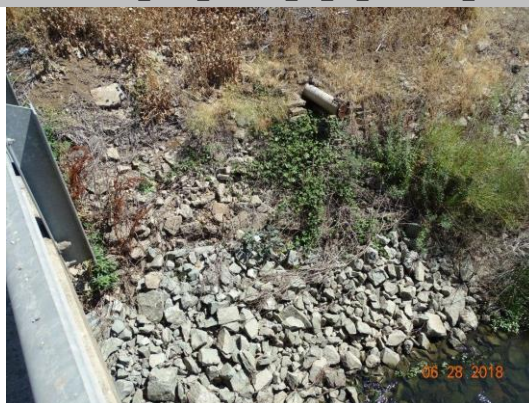
Photo 2 of 2 : CH_2019_NA0017_44_44_20190611_00014.jpg

View of the revetment on the right bank of the channel looking upstream.
Summer 2018

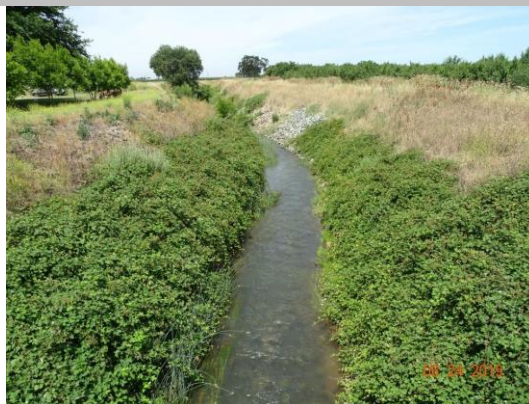
Photo 1 of 1 : CH_2019_NA0017_44_46_20190718_00069.jpg

Rating **	A	Issue No.	46	GPS Lat/Long
Issue Type +	Ma	Location *		37.913060 °
Category	Rivers, Channels & Designated Flood			-121.056230 °
Item	Vegetation & Obstructions			
DWR ID	DWR_NA0017_44_c_2012_46			
Action/Comments				
Inspector Comments: There is minimal vegetation within the channel, flow is not likely to be impeded.

View of channel looking downstream. Summer 2019

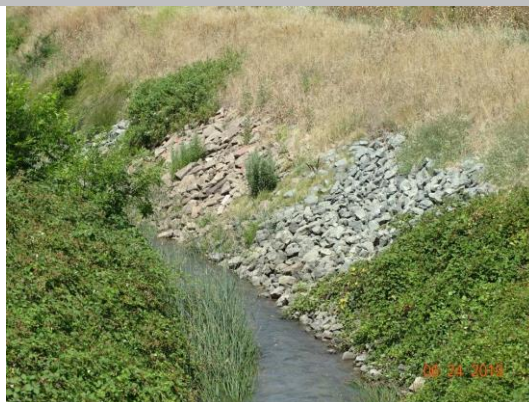
Photo 1 of 2 : CH_2019_NA0017_44_49_20190718_00070.jpg

Inspector Comments: Riprap is visible and appears to be undamaged.

View of existing revetment looking downstream. Summer 2019

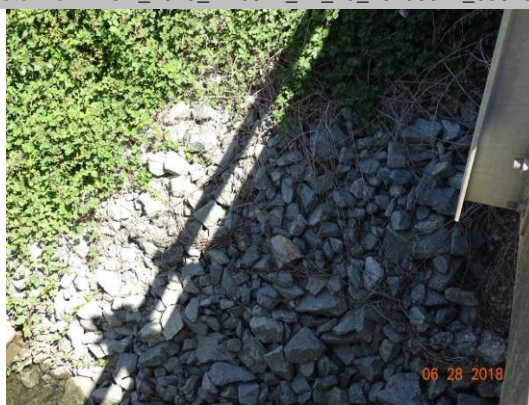
Photo 2 of 2 : CH_2019_NA0017_44_49_20190611_00016.jpg

View of the existing revetment looking downstream. Summer 2018

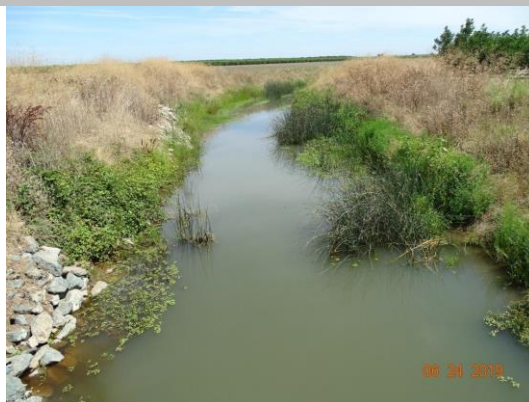
Photo 1 of 1 : CH_2019_NA0017_44_51_20190718_00071.jpg

Inspector Comments: There is minimal vegetation within the channel, flow is not likely to be impeded.

View of vegetation looking upstream. Summer 2019
